Use of Shrinkage-Compensating Concrete in Post-Tensioned Buildings

Part Two: A Four-Building Survey
By Kenneth B. Bondy, S.E., FACI

John Wayne Airport Parking Structures A2 and B2, Santa Ana, CA

Ridgecrest Community Residence, University Of Alabama, Tuscaloosa

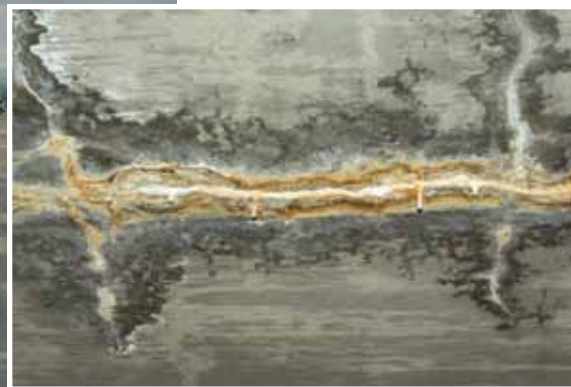
Figure 1: Efflorescence at crack on L1 slab soffit.

were measured and repaired in the 480,000 square feet of floor area in both structures. Prior to repair, some of the cracks allowed the passage of water through the slab, resulting in unsightly efflorescence at the slab soffit and potential damage to cars below (Figure 1).

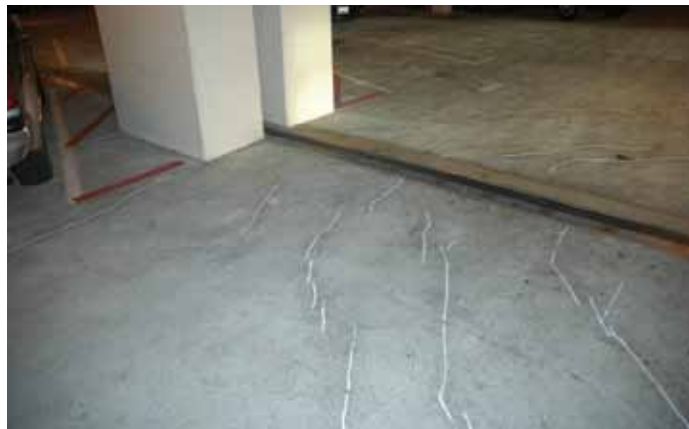
Figure 3: Top of slab near expansion joint, structure A2 Level L1.

Figure 3 (page 27) shows the top of the slab at a double column straddling the expansion joint at the L1 level. Diagonal cracks radiate off the columns in an orientation consistent with RTS on either side of the expansion joint. Figure 4 shows the top of the slab on the L2 level, exactly one floor above the location shown in Figure 3. The slab is crack free at this location.

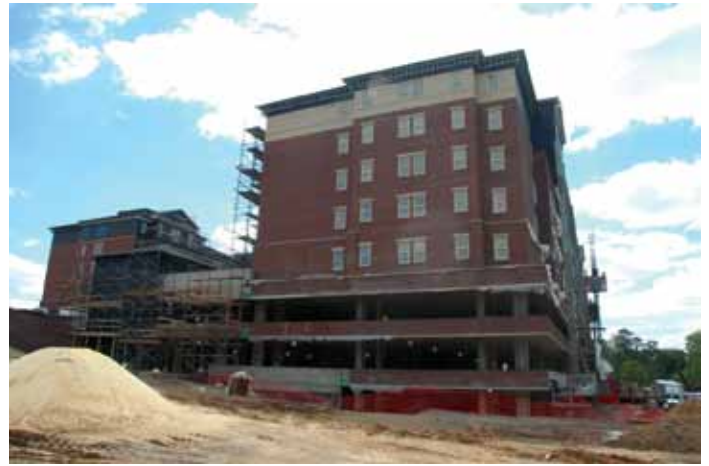
The photograph in Figure 5 was taken in April, 2009 when the building was structurally complete but architectural finish work was still underway.

Figure 5: North elevation showing three lower parking levels and five upper residential levels.
